TRAIL PAVEMENT CONDITION ASSESSMENT

NOVEMBER 2015

PREPARED FOR:
INGHAM COUNTY PARKS DEPARTMENT
121 E. MAPLE STREET
MASON, MICHIGAN 48854

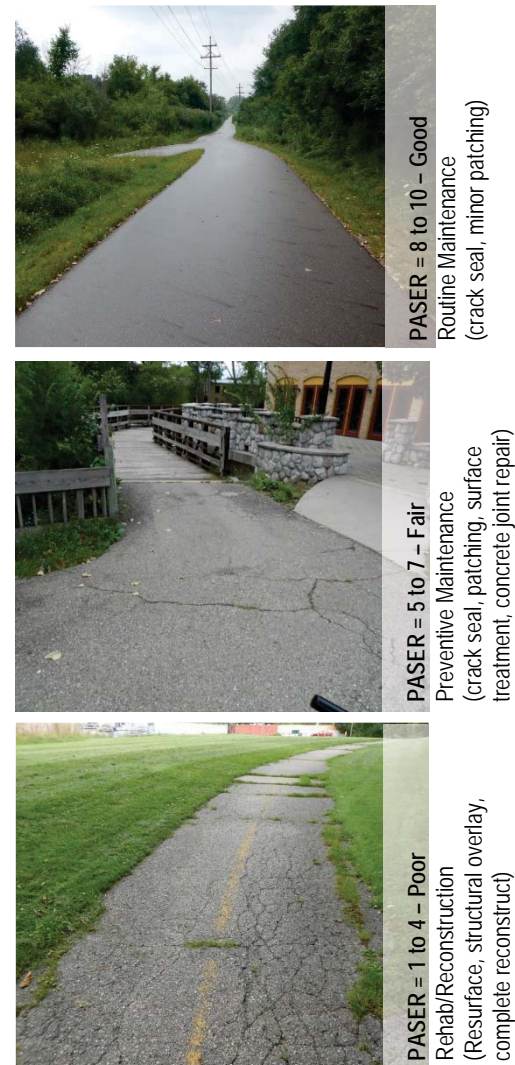
Trail Segment PASER Rating System Examples

MSG has utilized the PASER rating system for pavement surfaces and a proprietary scale for defining the conditions of the pavement base, drainage capability, and shoulder condition of each segment. PASER is an acronym for **P**avement **S**urface **E**valuation and **R**ating system, which was developed by the University of Wisconsin-Madison Transportation Information Center. Michigan has chosen to use the PASER rating scale for pavement surfaces, though there are a number of other rating methodologies widely available. In the PASER system, pavement segments are assigned ratings of 1 to 10, with 1 being the lowest rating, or totally failed condition, and 10 being the highest rating, or brand-new condition. This report will not go into the details of the PASER rating system other than to identify it as a useful tool to evaluate the trail system. Pavement segments must be regularly reviewed following their initial assessment in order to document changes in conditions, which will also permit the agency to develop life-cycle curves and further analyze the trail network's response to various repair methods.

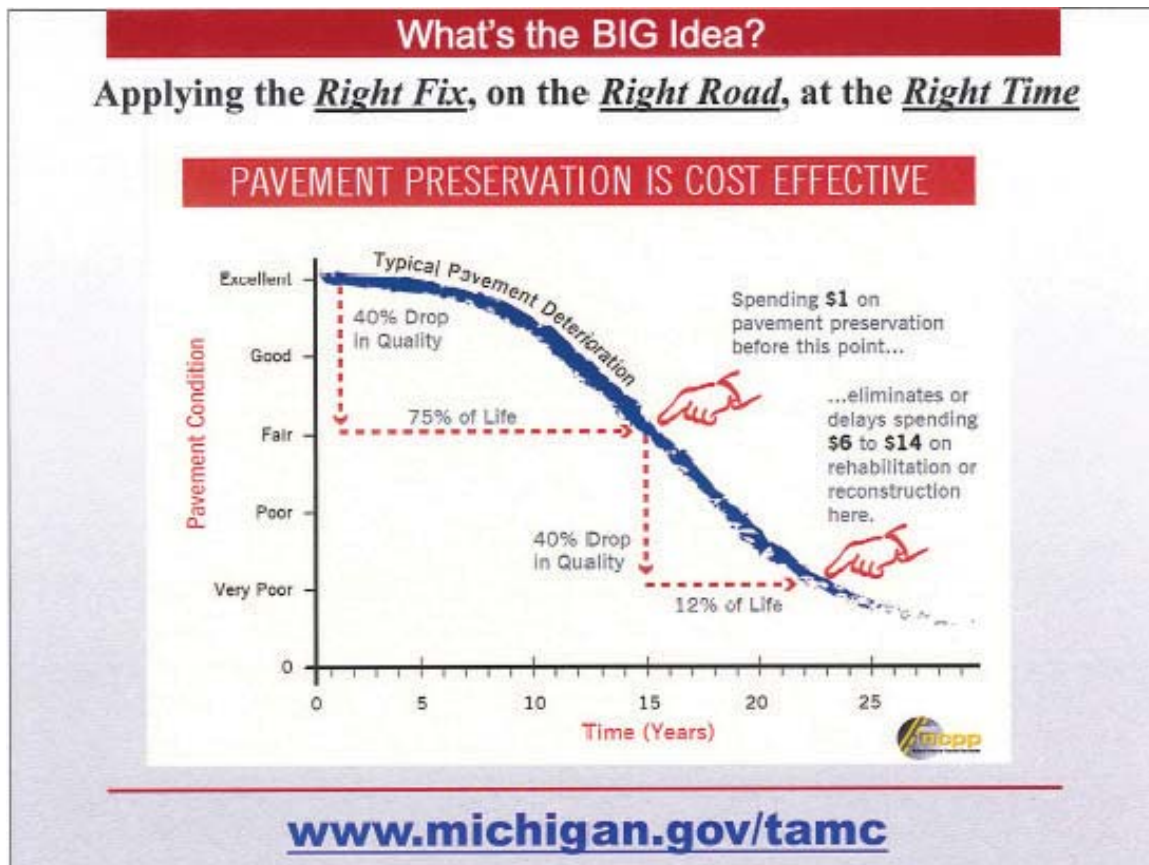
The chart that follows demonstrates a typical pavement deterioration curve with pavement condition being shown on the left hand, or 'y' axis, and the length in time (in years) across the bottom, or 'x' axis. The purpose of this chart is to demonstrate the benefits of providing lower-cost maintenance at critical times within the traditional pavement life cycle. If the right maintenance is provided at the right time, it will significantly delay the need for more intense, and costly, maintenance activities or the 'budget busting' cost of full reconstruction. Typical maintenance activities include crack sealing, sealcoat surfacing (also known as chip seals), microsurfacing, slurry sealing, thin lift overlays, milling and resurfacing, and other 'fixes' that preserve the existing pavement and provide a greater life span – as well as a better riding surface and public perception.

In general, the chart shows that there is approximately a 40% drop in pavement quality over a period of 75% of the pavement life cycle, which is typically defined (and engineered) in the industry as 20 years. If maintenance activities are not performed either prior to or by this time, there is a significant deterioration in the remaining years, estimated as an additional 40% deterioration in only 12% of the life cycle. The goal is to delay the eventual need for more significant rehabilitation or reconstruction as long as possible, and thereby preserving precious funding dollars and stretching them over a greater segment of the overall trail system.
